Failure Analysis of O-Rings

A global engineering and technology services company submitted O-rings for failure analysis following in-service failure after approximately eight years of operation. The seals were used in a process gas application operating at 139.3 bar(g), with a temperature range of 2°C to 32°C.

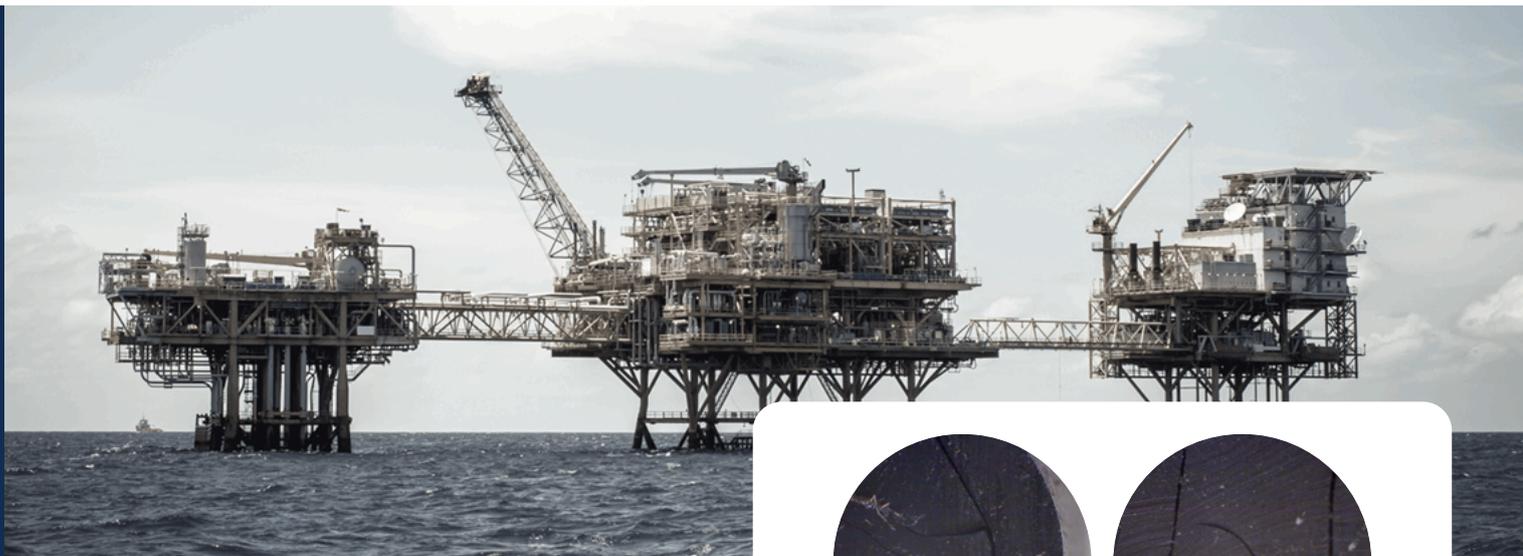
Initial visual inspection indicated damage consistent with rapid gas decompression (RGD). The failure characteristics included localised internal damage and swelling confined to the affected areas. There was:

The swelling observed was limited to the damaged regions and was not uniform across the seal body, further supporting a mechanical failure mechanism rather than chemical incompatibility.

Seat O-ring cross section, showing damage

Adaptor O-ring cross section, showing damage

To prevent recurrence and improve service life in high-pressure gas applications, it was recommended that the seals be replaced with an RB13 profile manufactured from an RGD-resistant HNBR compound. This material selection would provide improved resistance to decompression damage and significantly increase seal reliability under the stated operating conditions. We subsequently manufactured the recommended seals, which demonstrated successful performance in operation.
