Wellhead Tree Hanger Neck Face Seal

As part of the Wellhead maintenance campaign at an oil production/gas storage facility in Southern England, the hanger neck face seal failed its pressure test. A sealant injection system was deployed to try and solve the problem but without success. With the failure of the sealant injection system, it was decided to replace the metallic C-seal and test again.

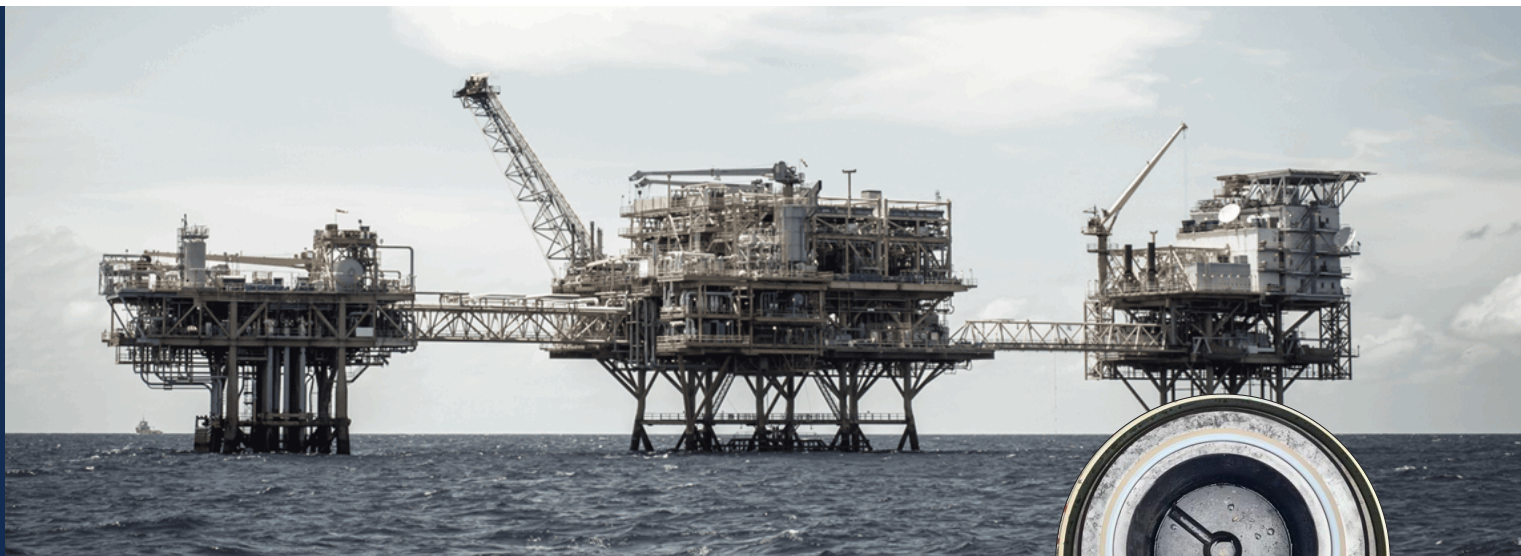
The issue however was the large 0.063" extrusion gap that for some unknown reason had been incorporated into the original design.

Our proposal to solve the problem was to provide a special helical spring energised virgin PTFE internal pressure sealing face seal, with a PEEK 'top hat' design back-up ring/anti-crush ring. This would be a retrofit design, to fit the existing groove of the metal C-seal.

The benefits of this design were that the 'top hat' PEEK back-up ring would act as an anti-extrusion device, filling the above mentioned extrusion gap, but also act as a groove depth limiter. This would ensure the correct groove depth for the PTFE seal to function and provide the correct amount of pre-compression on the helicoil spring energiser.
