## Spring Energised Seals for Cryogenic Quick Connect / Disconnect Coupler

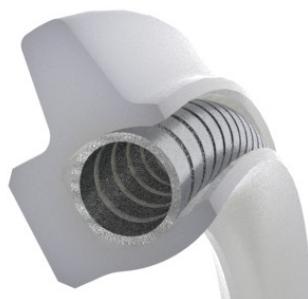
Seals were supplied to our customer 3 days after our initial assessment and easily installed into the QCDC after the initial lead-in chamfer modification had been made. The seal was placed under rigorous quick connect / disconnect procedures at -196°C for 168 hours and zero leakage was recorded. Our client was so pleased with the results of the test and the speed in which we had reacted to their problem that we were invited to look at a secondary seal design. This new seal was similar to the initial brief, but with an angled sealing face as per the image on the right of this page. Tests were repeated and zero leakage was once again reported.
