Spring Energised Seals for Cryogenic Quick Connect / Disconnect Coupler

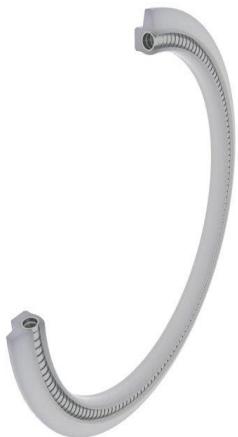
We designed a bespoke spring energised seal which would utilise our customers existing metalwork, this meant no redesign work was required by our client. The combination of a special high-load spring energiser and fluoropolymer seal jacket was proposed to enable the seal to provide leak-tight performance and resist shrinkage while performing at cryogenic temperatures.
