## Seals for Protection Sleeve

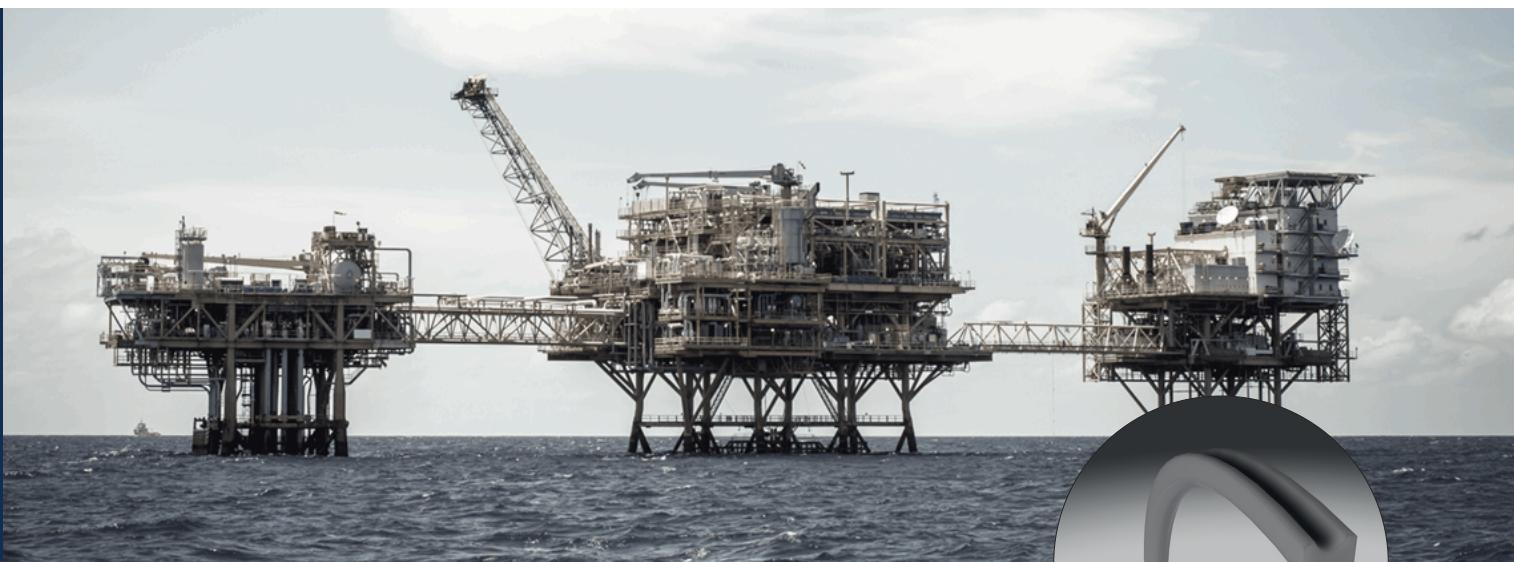
Due to the un-machined surface with poor finish, a seal with a substantial cross-section for better compression was chosen. We opted for a customised SB35 profile featuring a larger cross-section and a deeper external groove to facilitate easier compression and effective sealing against the pipe's irregular surface.
